DEPARTMENT OF TRANSPORTATION

Contract #: 04-0120F4Cty: SF/ALA Rte: 80 PM: 13.2/13.9File #: 69.28**WELDING INSPECTION REPORT****Resident Engineer:**Siegenthaler, Peter**Address:** 333 Burma Road**City:** Oakland, CA 94607**Report No:** WIR-024851**Date Inspected:** 30-Jun-2011**Project Name:** SAS Superstructure**OSM Arrival Time:** 700**Prime Contractor:** American Bridge/Fluor Enterprises, a JV**OSM Departure Time:** 1900**Contractor:** Zhenhua Port Machinery Company, Ltd (ZPMC), Changxing Island **Location:** Shanghai,China

OBG Segment 14E

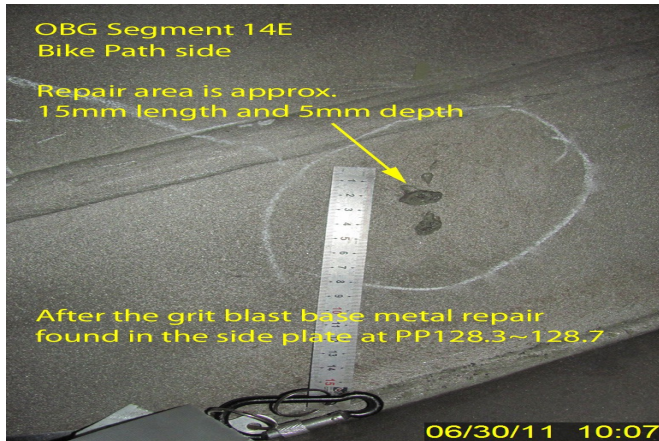
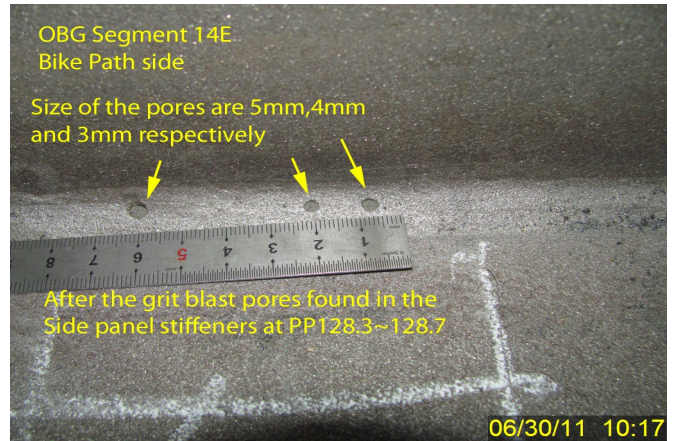
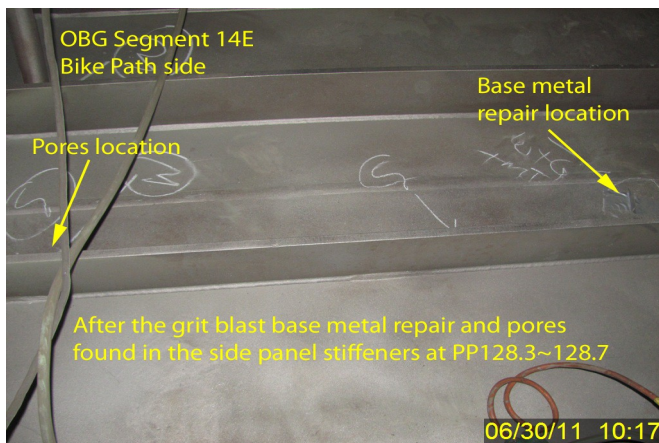
This QA Inspector performed a preliminary random visual inspection after the grit blast of the Interior components of the Side panel stiffeners and Floor Beam of this segment. Areas of visual weld defects that will require welding were taped and will be repaired after the coating is applied. ZPMC QC personnel are aware of these areas and were present during the inspection. Please see the attached picture.
